NOTIFICATION OF REQUIRED SEWER RECONSTRUCTION

RE: Manhattan BOROUGH 8 COMM. BD. M1 POLICE PCT. M1 SEWER YARD 185304432 C.S. #/W.O. #

#105 E 67 ST B/T Park + Lexington (Approx 20' E of Park)

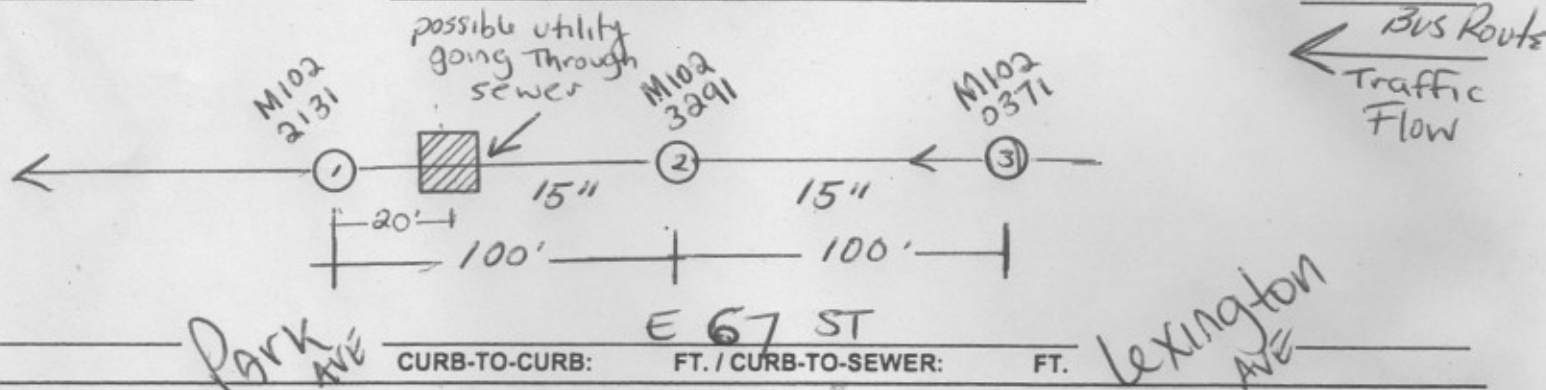
LOCATION OF BREAK/BLOCKAGE IS APPROXIMATELY IN FRONT OF BUILDING #

AND FOUND THE FOLLOWING CONDITION TO EXIST: 8x10 Collapse over broken 15" Sewer

Found possible utility running through sewer at the point of collapse Repair + Restore

TYPE Vit MATERIAL Comb PIPE SAMPLE 15" SIZE(S) 15" SEWER DEPTH (FT.) 9 (@ UPSTREAM M/H) SEWER DEPTH (FT.) 10 (@ DOWNSTREAM M/H) BREAK LENGTH N/A
