Efflorescence: Cause and Control¹

This article explains the mechanics of white efflorescence, how to help prevent efflorescence and some traditional methods used to remove efflorescence from new walls.

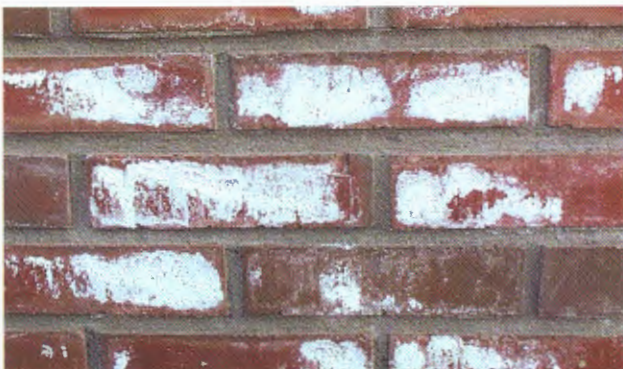
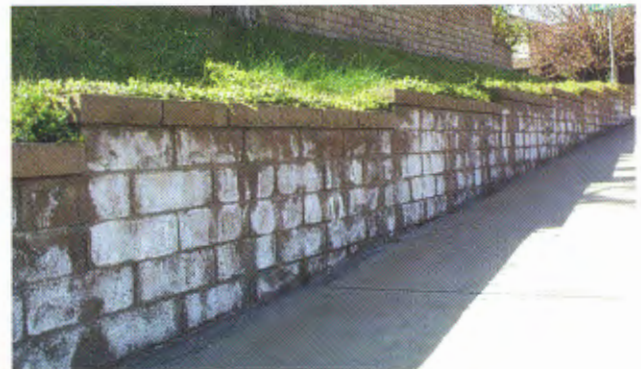
Figure 1. Typical white efflorescent salts on brick and block masonry

We know that efflorescence is a fine, white, powdery deposit of water-soluble salts left on the surface of masonry as the water evaporates. These efflorescent salt deposits tend to appear at the worst times, usually about a month after the building is constructed, and sometimes as long as a year after completion.

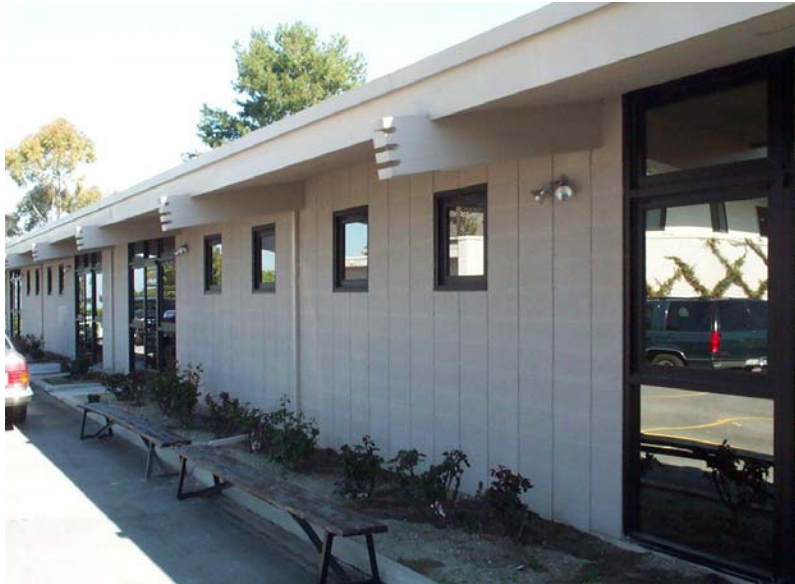
Figure 3. Overhanging eaves will help greatly to prevent moisture from entering this stack bond CMU wall.

The next critical concern is to prevent any water from penetrating into the masonry wall where it could cause efflorescence to occur. This can be done with good architectural details and quality masonry construction. Designing with overhanging eaves, copings and flashings, and careful attention to landscaping and sprinklers will reduce the chances of water entering the wall. In addition, specifying tooled, compacted mortar joints (concave or "V" type) will also reduce the potential for water infiltration. See Figures 3 and 4 for good efflorescence controlling design.

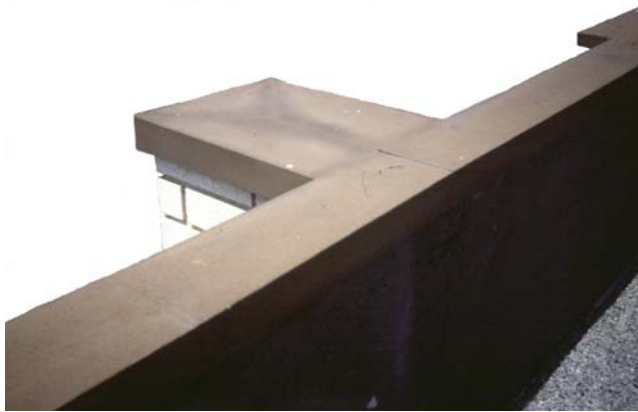
Figure 4. A full metal coping helps in waterproofing a wall and eliminates moisture penetration through the tops of parapets
