Cooperative Intersection Collision Avoidance System Limited to Stop Sign and Traffic Signal Violations (CICAS-V)

Subtask 3.4 Interim Report

Human Factors Pilot Test of the CICAS-V

September 30, 2008

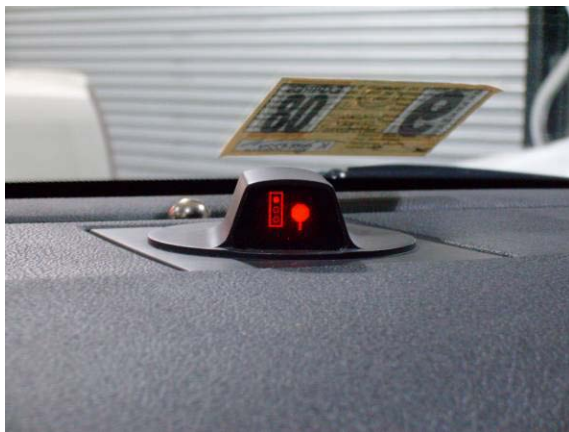
The auditory warning consisted of a female voice stating "Stop Light" or "Stop-Sign", presented at 72.6 dBA via the front speakers, measured at the location of the driver's head. The visual warning (Figure 1) displayed a traffic signal and stop-sign icon from a high "head down" display located on top, center of the dashboard near the windshield. Finally, the haptic brake pulse warning consisted of a single 600 millisecond brake pulse (or vehicle jerk) presented in conjunction with the visual icon and an auditory warning.

Figure 1 The visual display is located on the dash of the experimental vehicle.

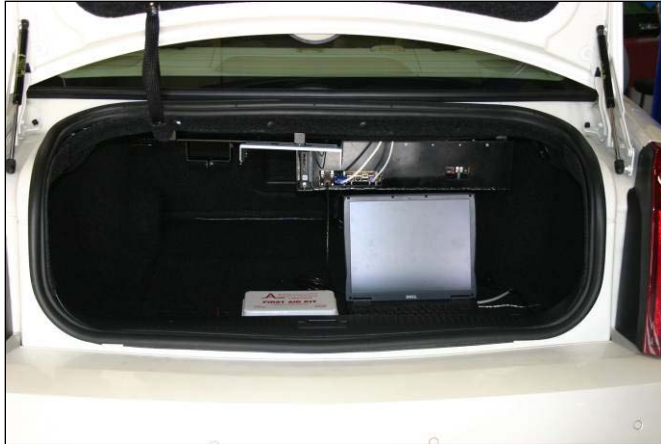
Figure 5 DAS, installed in the vehicle trunk underneath the rear shelf.

The vehicle DAS hardware consisted of a main unit, a video system, front and rear radar, and a GPS unit. The main unit contained an Embedded Platform for Industrial Computing (EPIC) single-board computer, hard drive, CAN communication, battery backup system, and several VTTI-developed sensor modules. Four unobtrusive cameras installed in the passenger compartment captured the scene in and around the vehicle.

The vehicle DAS (Figure 5) was used to record digital video and kinematic data from multiple sources, and was composed of hardware, software, and data storage components.

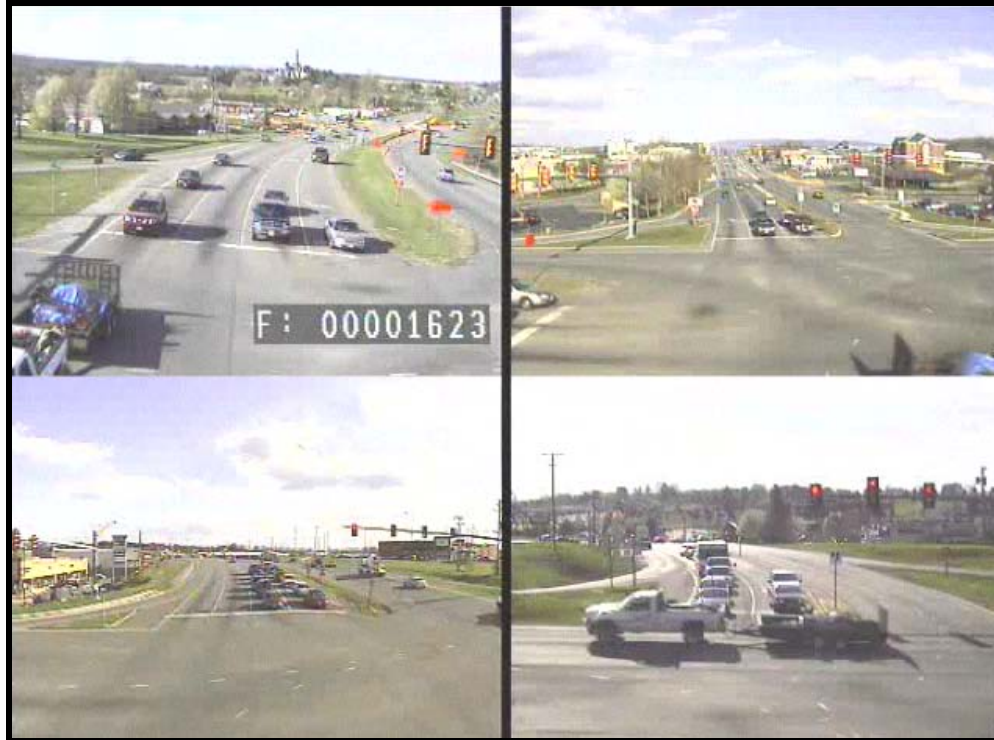
As discussed in section 2.2.1, the RSE used a second WSU to perform the CICAS-V roadside tasks. The DAS was attached to the RSE via a CAN bus and received data packets containing the SPaT. A video camera was installed on each of the four traffic signal mast arms to provide an image of the entire intersection environment (Figure 9).

Figure 9 Video quadrants from camera units mounted on intersection mast arms.

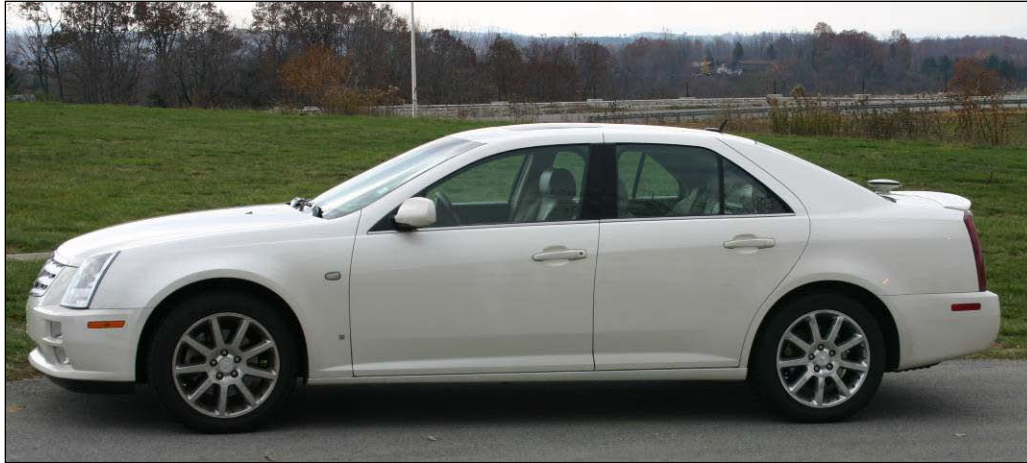
Figure 12 Experimental vehicle, 2006 Cadillac STS

After undergoing the initial paper work process, participants were led outside where the experimenter introduced them to the test vehicle (Figure 12). Participants were given a brief tutorial on basic vehicle functions, including ignition procedures, seat movement, and the HVAC system. During the static pre-drive vehicle orientation, the different safety systems available in the experimental vehicle were briefly reviewed. The systems reviewed with the participants included the forward collision warning, backing aid, and the CICAS-V such that drivers were led to believe that various safety systems were being evaluated. The goal was to make the driver aware of the CICAS-V but not to emphasize it over the other available vehicle safety technologies. These additional safety systems were enabled in the vehicle; however, it is unknown as to whether any of the drivers received alerts during the study.

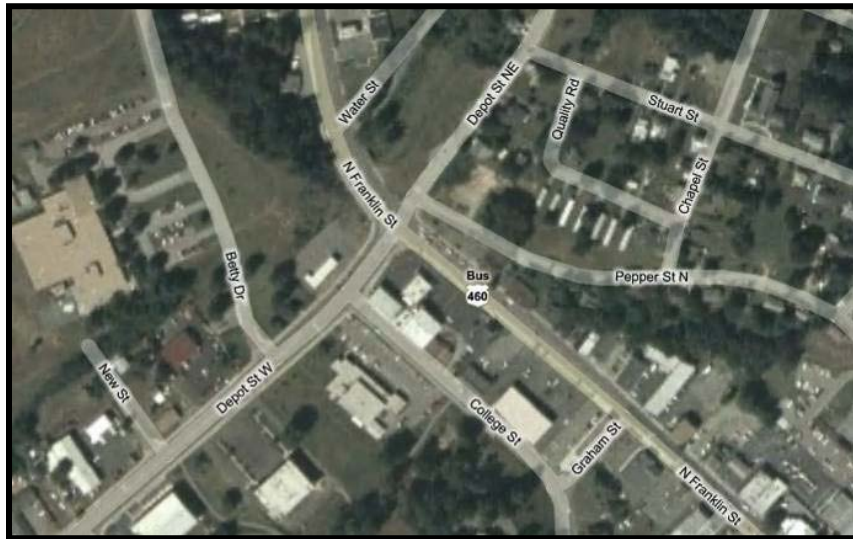
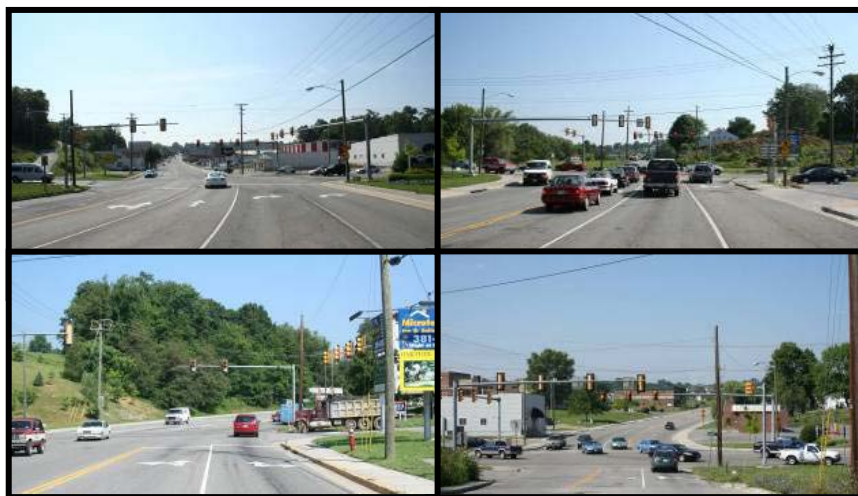
The intersection of Depot Street and Franklin Street (Intersection 6) is a four-way signalized intersection with a traffic light presented to vehicles traveling on both Franklin Street and Depot Street. The Franklin Street eastbound intersection approach has a 35 mph posted speed limit, while the westbound intersection approach has a 25 mph posted speed limit. The Depot Street intersection approach has a 25 mph posted speed limit going southbound and a 35 mph posted speed limit going northbound. An aerial view and ground images of Intersection 6 are presented in Figure 18 and Figure 19, respectively.

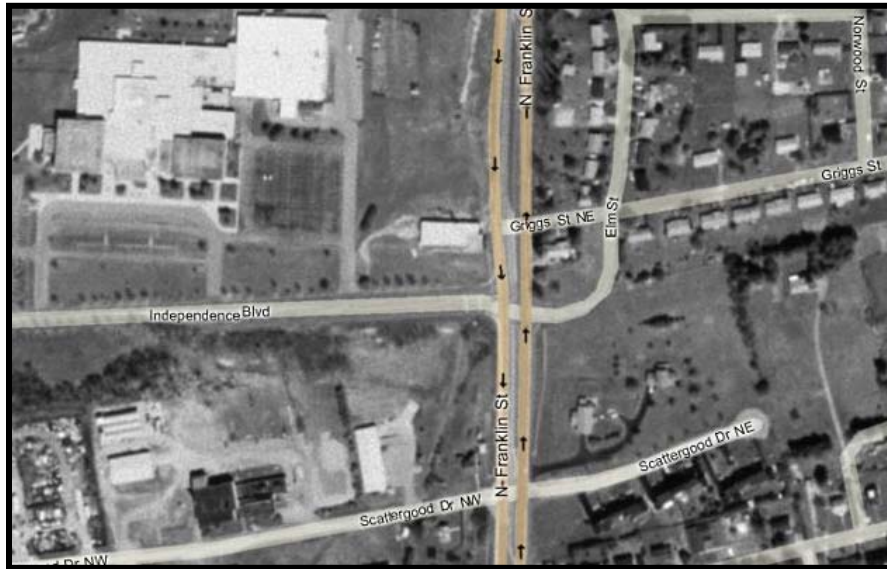
The intersection of Franklin Street and Independence Boulevard (Intersection 7) is a four-way signalized intersection with a traffic light presented to vehicles traveling on Independence Boulevard, Elm Street, and both directions on Franklin. The posted speed limits for Franklin Street, Independence Boulevard and Elm Street are 45 mph, 35 mph, and 25 mph, respectively. An aerial view (Figure 20) and ground images (Figure 21) of Intersection 7 are provided below.

Figure 20 Aerial view Franklin, Elm & Independence intersection.

For the valid warning, a middle-aged male approached the Independence by Franklin signalized intersection to make a straight-crossing maneuver (see Appendix E, Figure 20). He was in the right-most straight-through-lane following a vehicle with about a one-second headway. The signal became visible in the video at 53m (173 ft) and is in the yellow state. The driver does not show any indication of intending to brake until after the pre-warning process (a 500 ms process to initialize the warning) has started. Three-hundred ms later, the driver begins to brake. The pre-warning process finished and a warning is issued 200 ms after the braking began. The driver brakes safely to a stop before crossing the stop bar. Although it cannot be determined with certainty, the driver's braking prior to the warning likely indicates intent to stop. The driver did not show any visible expression in response to the warning. If the driver had not stopped, it appears a violation would have occurred, based on the location of the lead vehicle, which crosses over the stop bar as the signal turned red.

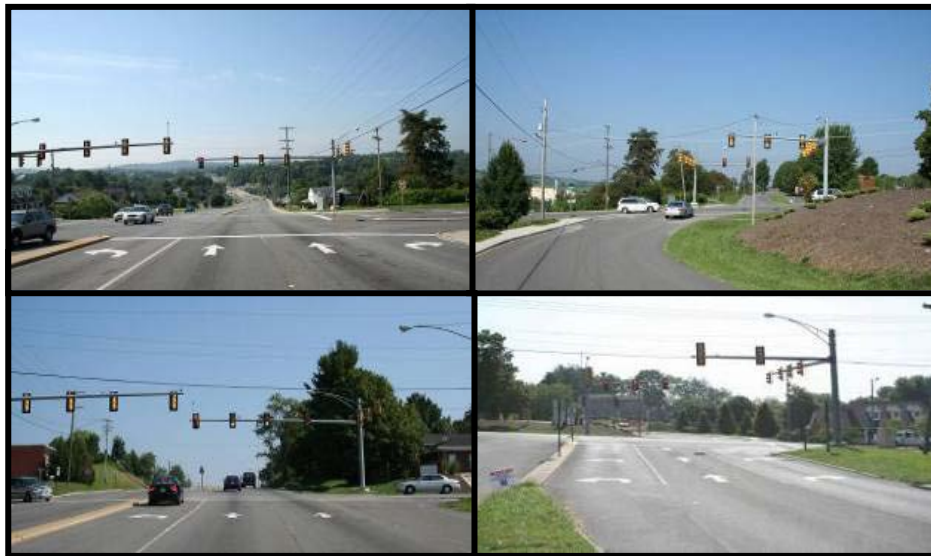
Figure 21 Ground images from Franklin, Elm & Independence intersection.

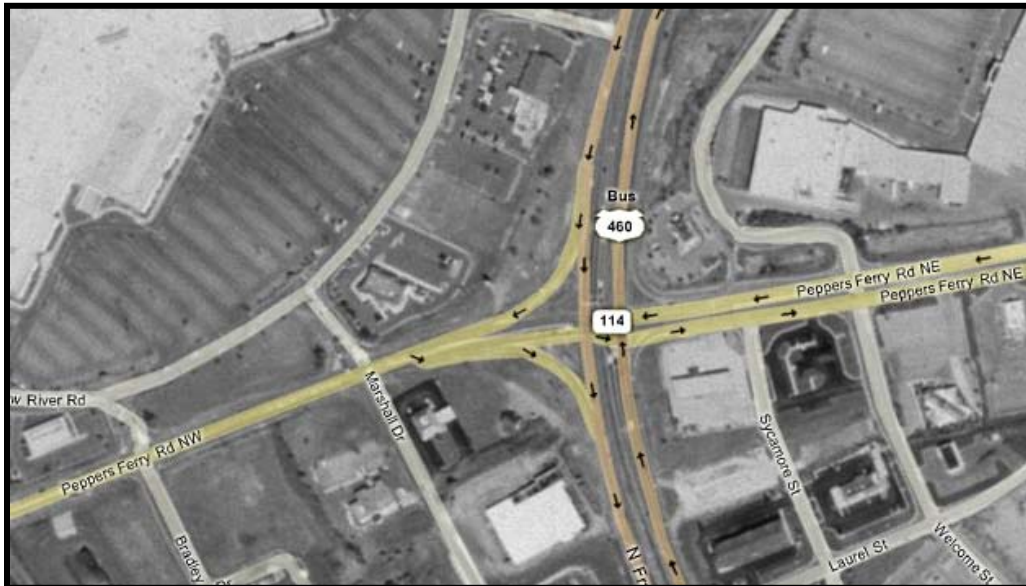
The intersection of Peppers Ferry and Franklin Street (Intersection 8) is a four-way signalized intersection with a traffic light presented to vehicles traveling on Peppers Ferry and Franklin Street. The Peppers Ferry intersection approach has a 35 mph posted speed limit in both westbound and eastbound directions. On Franklin there is a 45 mph posted speed limit in both northbound and southbound directions. An aerial view and ground images of Intersection 8 are presented in Figure 22 and Figure 23, respectively.

Figure 22 Aerial view of Peppers Ferry (VA-114) & Franklin (Bus460) intersection.

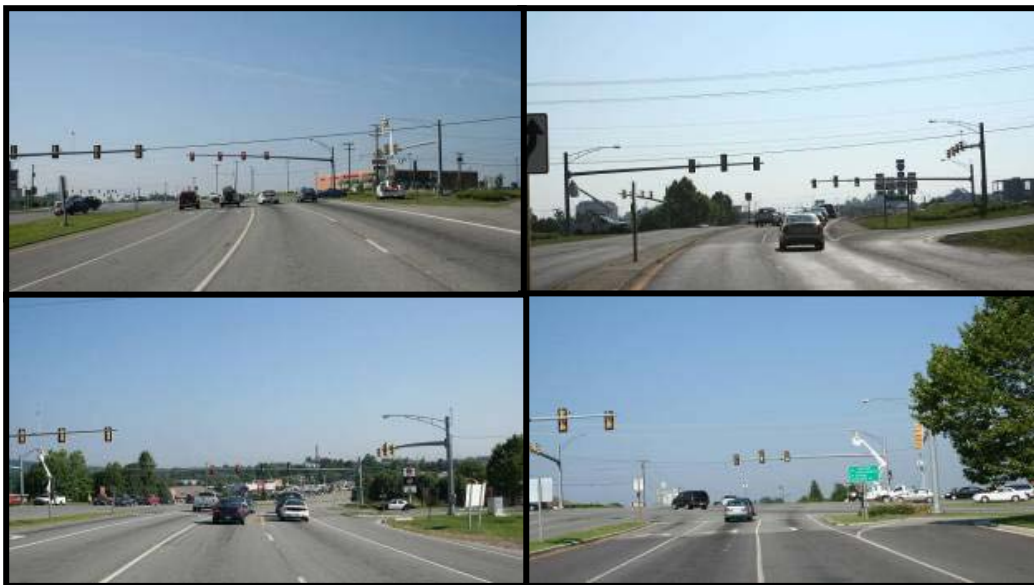
Figure 23 Ground images from Peppers Ferry (VA-114) & Franklin (Bus460) intersection.

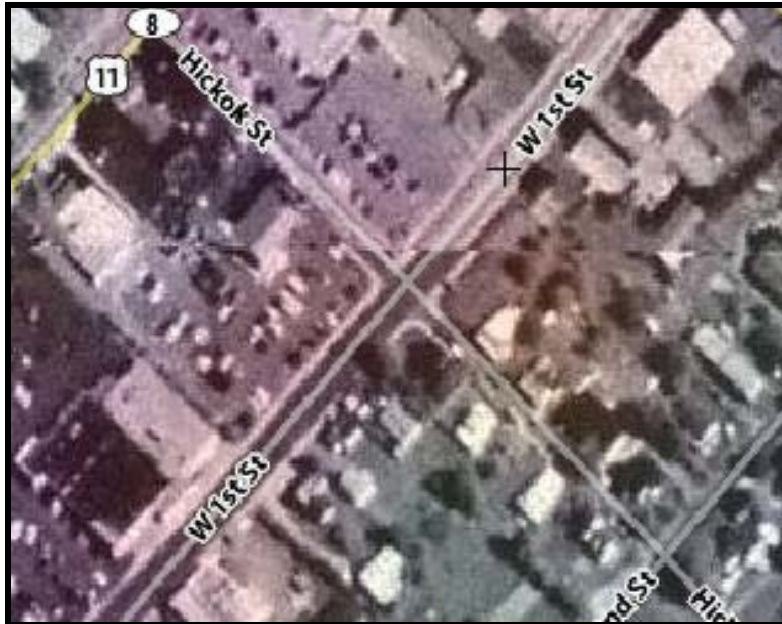
The intersection of Hickok Street and First Street (Intersection 12) is a four-way stop-controlled intersection with a single stop sign for vehicles traveling both directions on Hickok. The speed limit for traffic traveling on both Hickok Street and First Street is 25 mph. An aerial view and ground images of Intersection 12 are presented in Figure 24 and Figure 25, respectively.

Figure 24 Aerial view of Hickok and First Street intersection.

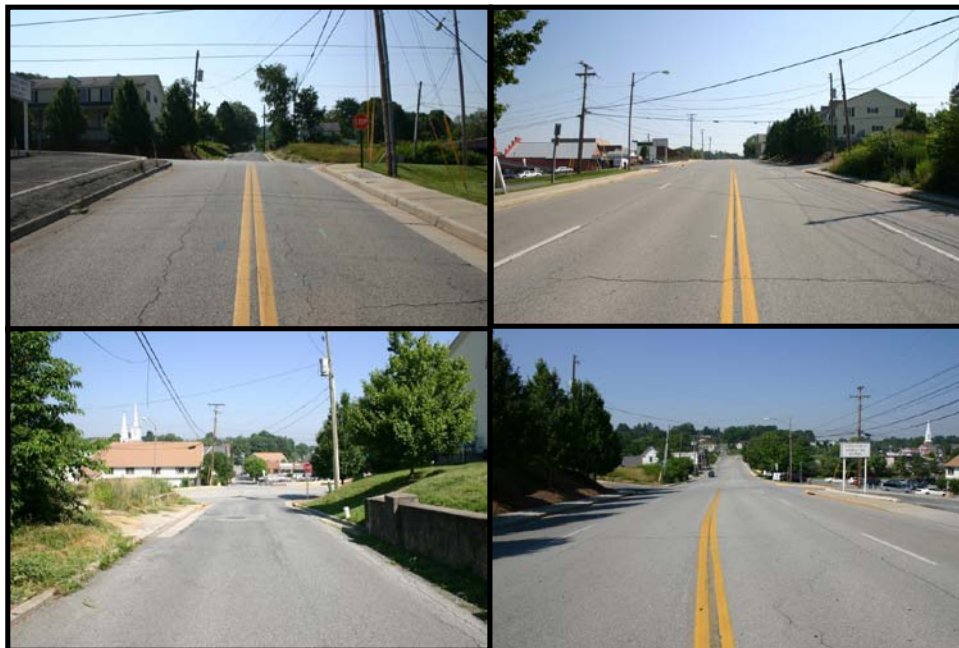
Figure 25 Ground images of Tranquility Via & Independence intersection

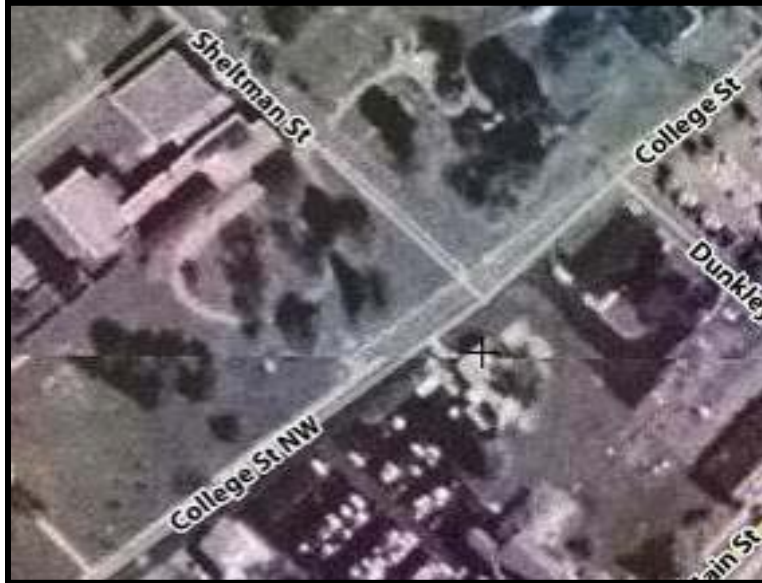
The intersection of Sheltman Street and College Street (Intersection 13) is a three-way stop-controlled intersection with a single stop sign for vehicles traveling on Sheltman Street. The speed limit for traffic traveling on both Sheltman Street and College Street is 25 mph. An aerial view and ground images of Intersection 13 are presented in Figure 26 and Figure 27, respectively.

Figure 26 Aerial view of Sheltman & College intersection.

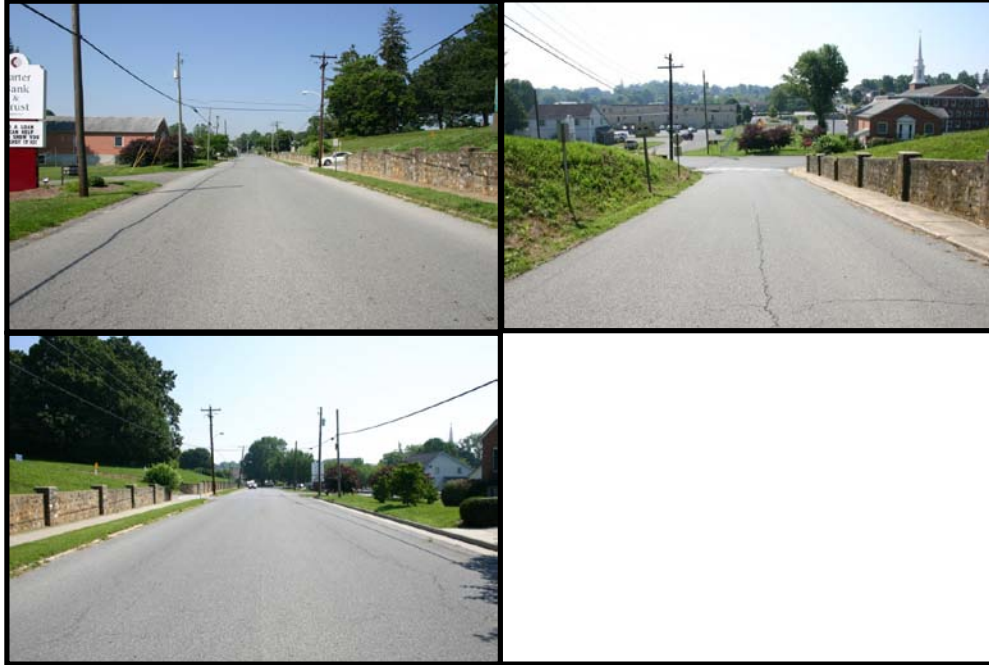
Figure 27 Ground images of Sheltman & College intersection.

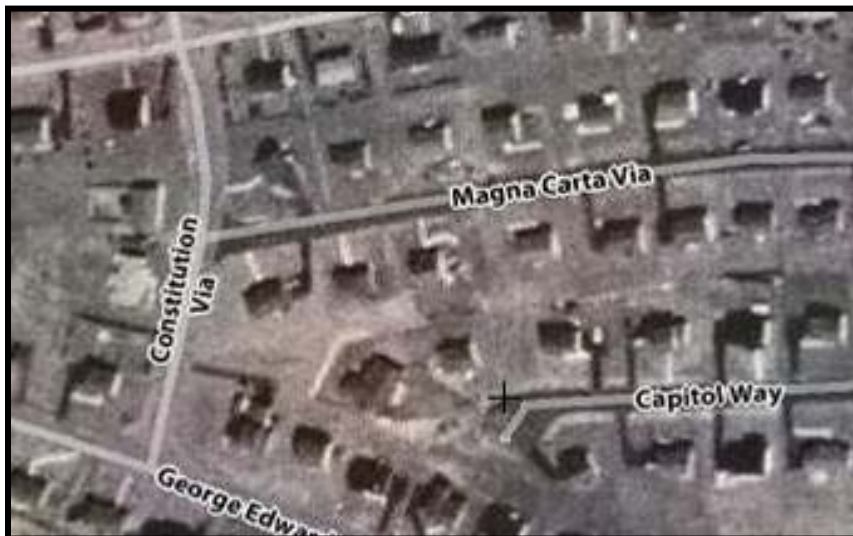
The intersection of Magna Carta Via and Constitution Via (Intersection 15) is a three-way stop-controlled intersection with a single stop sign for vehicles traveling on Magna Carta Via. The speed limit for traffic traveling on both Magna Carta and Constitution is 25 mph. An aerial view and ground images of Intersection 15 are presented in Figure 28 and Figure 29, respectively.

Figure 28 Aerial view of Magna Carta Via and Constitution Via.

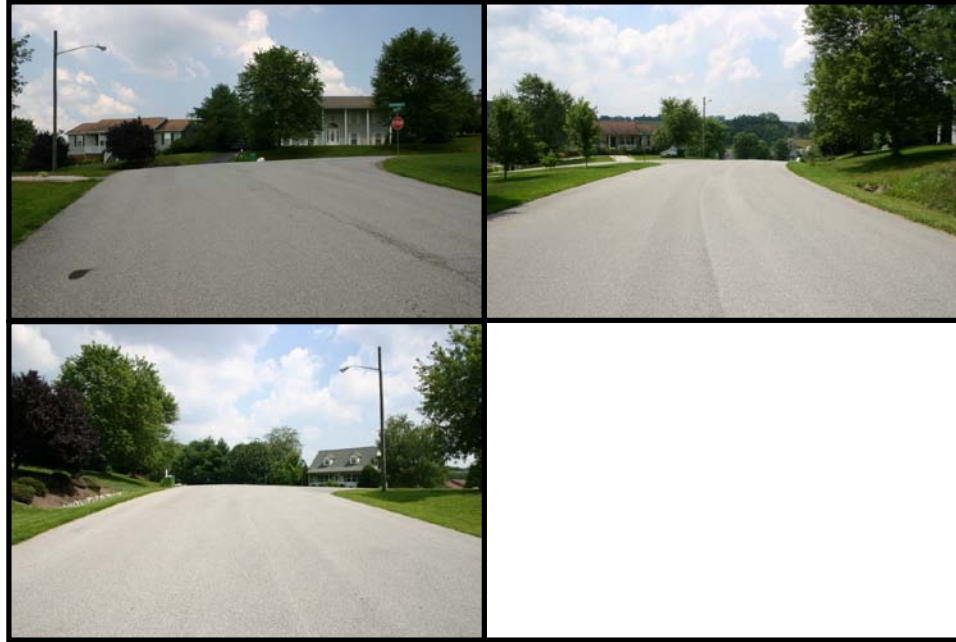
Figure 29 Ground images of Magna Carta Via and Constitution Via.

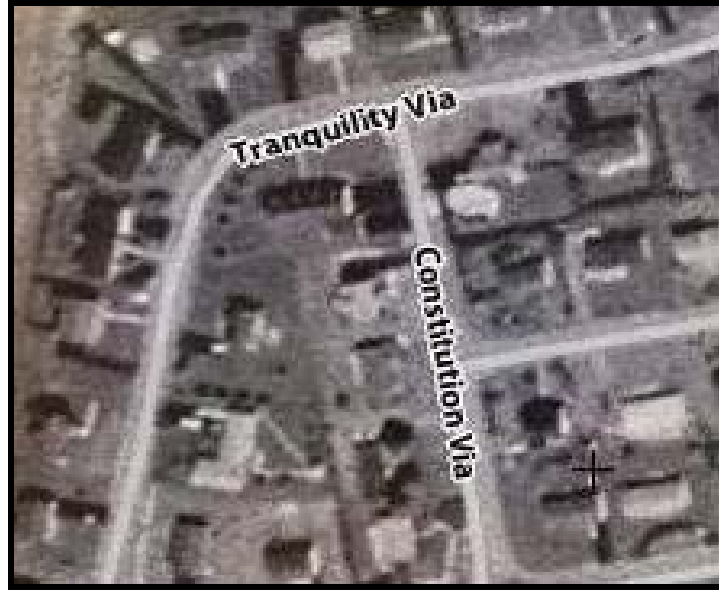
The intersection of Constitution Via and Tranquility Via (Intersection 17) is a three-way stop-controlled intersection with a single stop sign for vehicles traveling on Constitution Via. The speed limit for traffic traveling on both Constitution Via and Tranquility Via is 25 mph. An aerial view and ground images of Intersection 17 are presented in and Figure 31, respectively.

Figure 30 Aerial view of Constitution Via & Tranquility Via intersection.

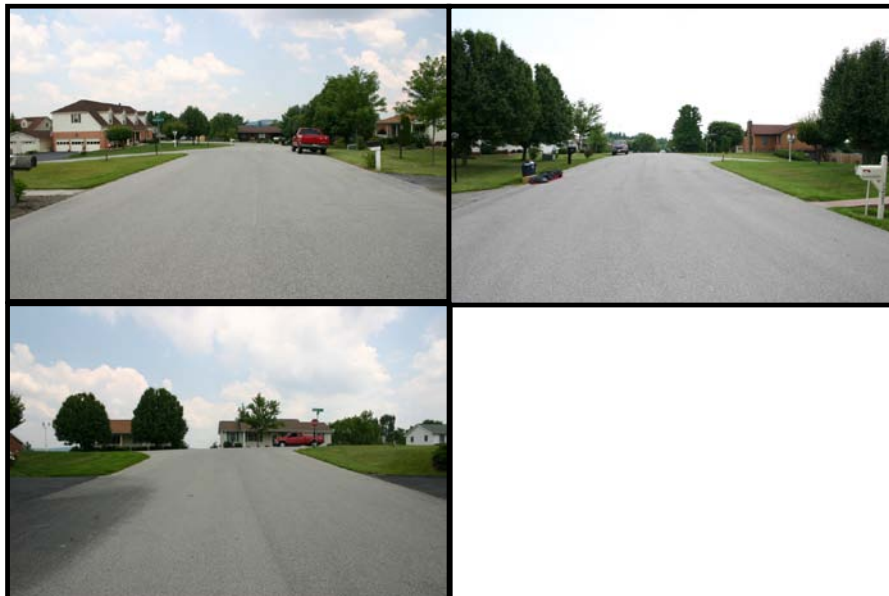
Figure 31 Ground images of Constitution Via & Tranquility Via intersection.

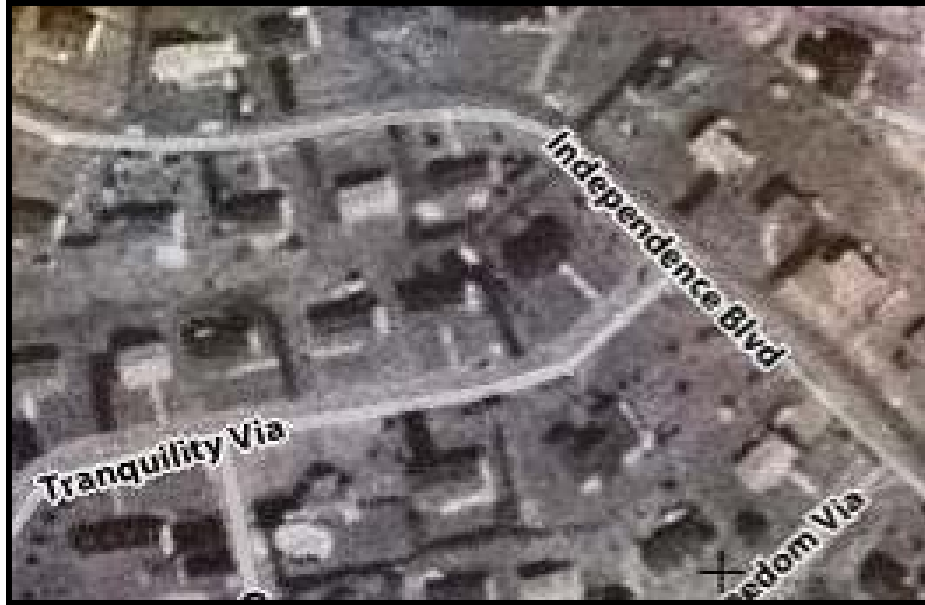
The intersection of Tranquility Via and Independence Via (Intersection 18) is a three-way stop-controlled intersection with a single stop sign for vehicles traveling on Tranquility Via. The speed limit for traffic traveling on both Tranquility Via and Independence Via is 25 mph. An aerial view and ground images of Intersection 18 are presented in Figure 32 and Figure 33, respectively.

Figure 32 Aerial view of Tranquility Via & Independence intersection.

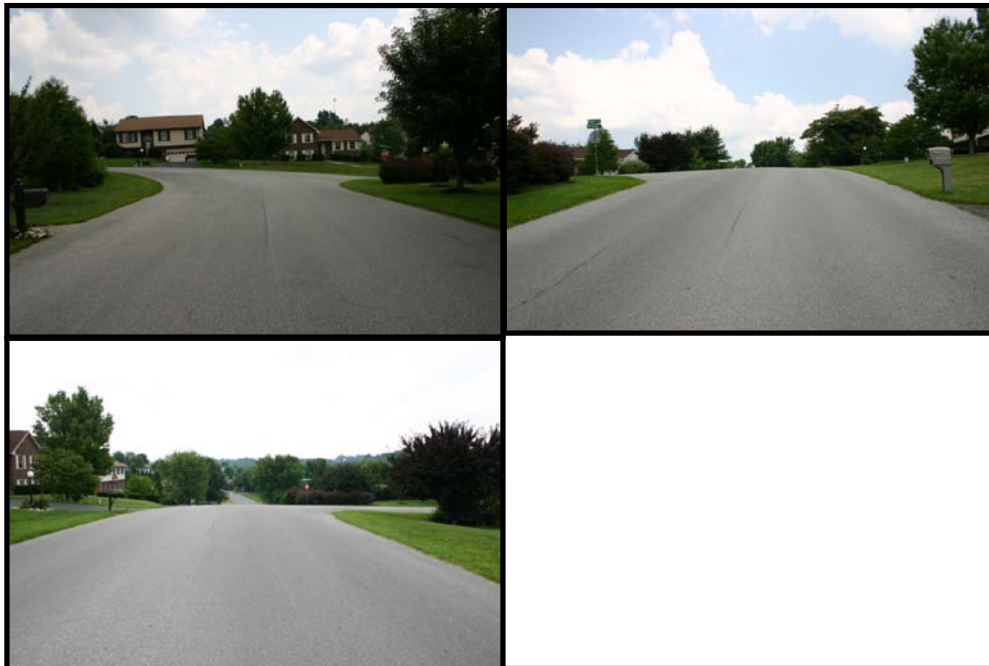
Figure 33 Ground images of Tranquility Via & Independence intersection.

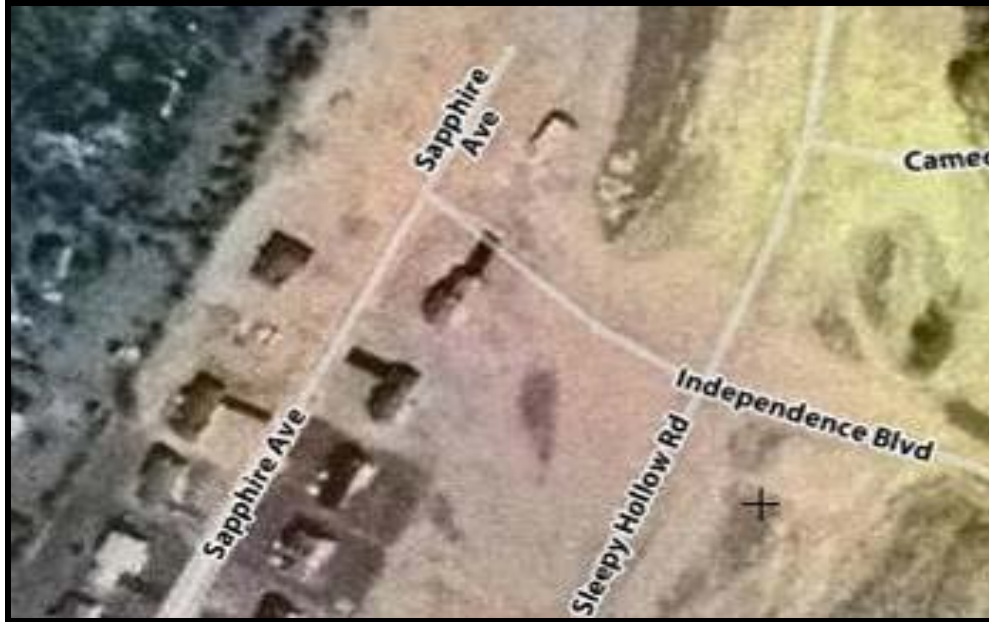
The intersection of Independence Blvd. and Sapphire Avenue (Intersection 19) is a three-way stop-controlled intersection with a single stop sign for vehicles traveling on Independence Blvd. The speed limit for traffic traveling on both Independence Blvd. and Sapphire Avenue is 25 mph. An aerial view and ground images of Intersection 19 are presented in Figure 34 and Figure 35, respectively.

Figure 34 Aerial view of Independence & Sapphire intersection.

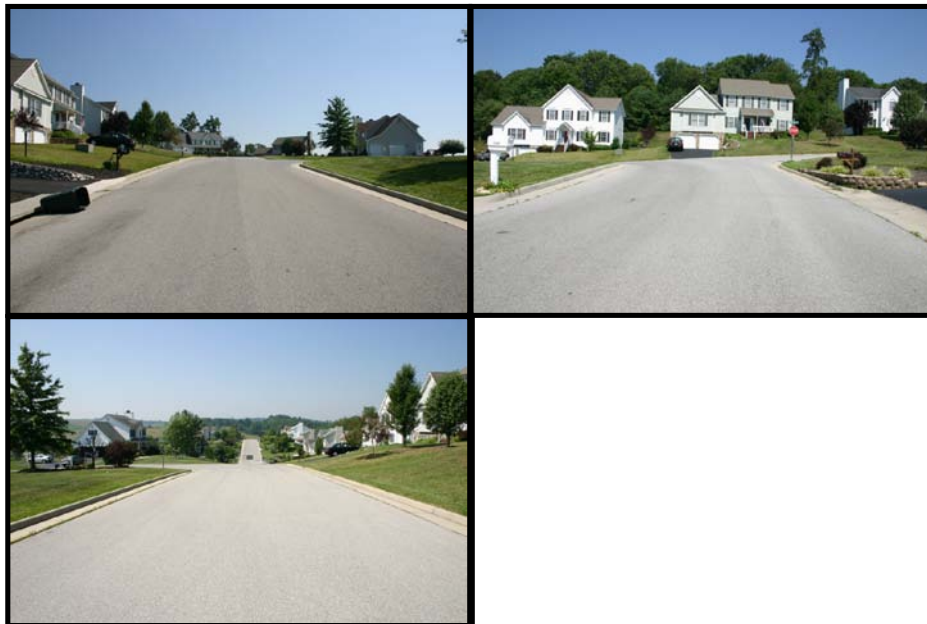
Figure 35 Ground images of Independence & Sapphire intersection.

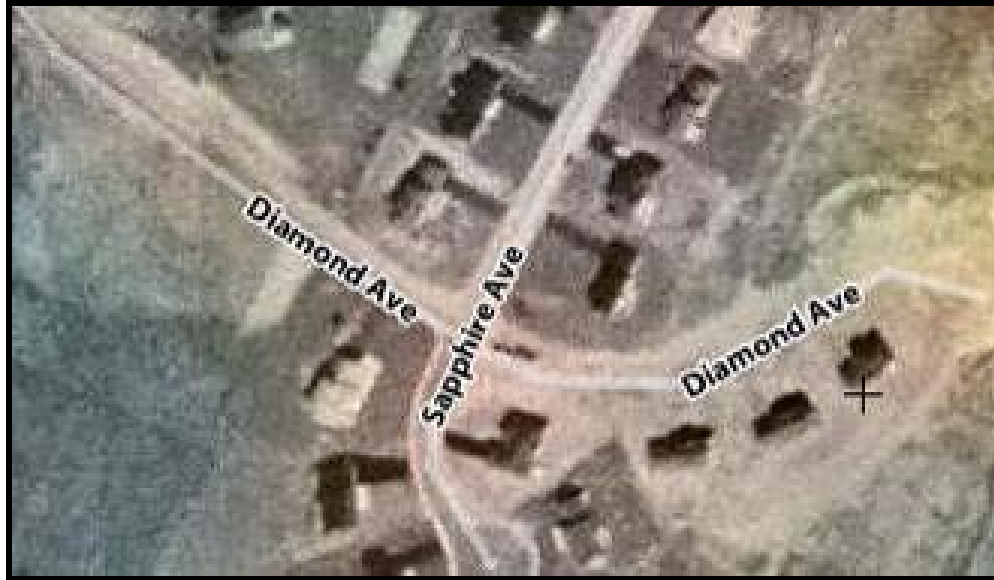
The intersection of Sapphire Avenue and Diamond Avenue (Intersection 20) is a four-way stop-controlled intersection with a single stop sign for vehicles traveling both directions on Sapphire Avenue and Diamond Avenue. The speed limit for traffic traveling on both Sapphire Avenue and Diamond Avenue is 25 mph. An aerial view and ground images of Intersection 20 are presented in Figure 36 and Figure 37, respectively.

Figure 36 Aerial view of Sapphire & Diamond intersection.

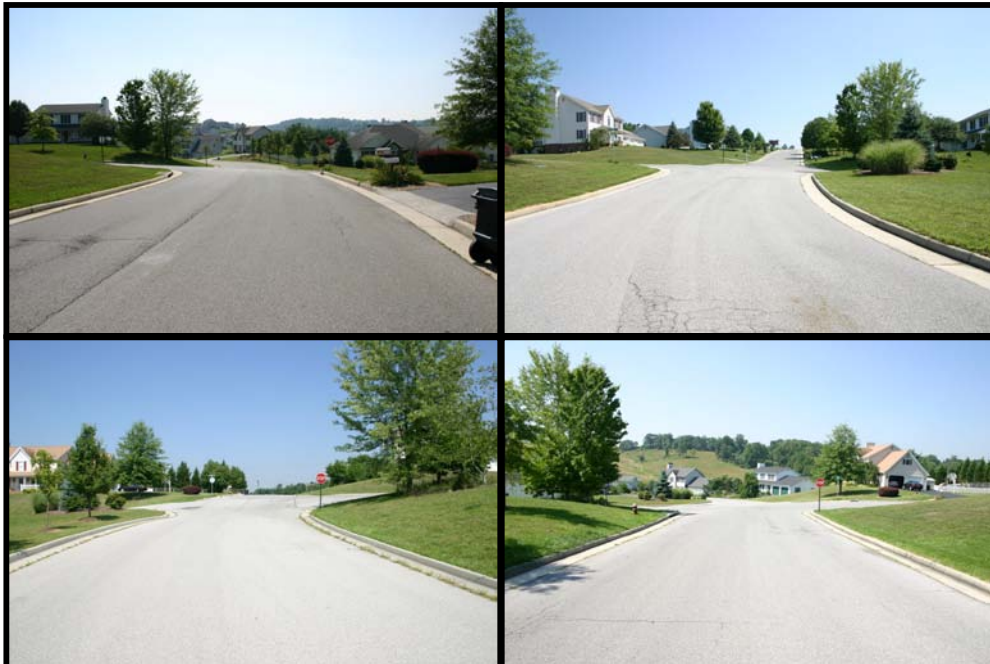
Figure 37 Ground images of Sapphire & Diamond intersection.

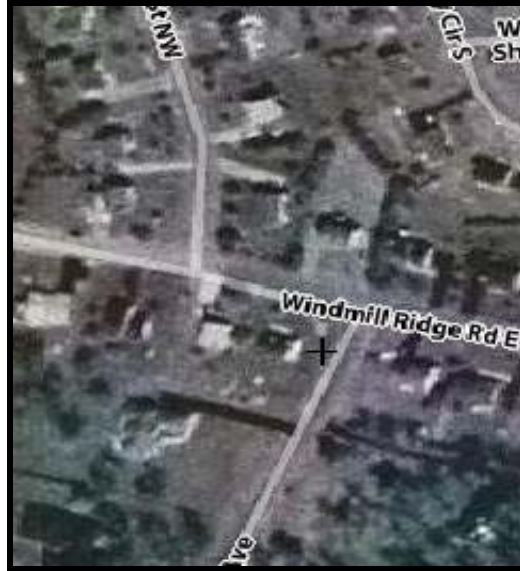
The intersection of Windmill Ridge Road and Cambria (Intersection 22) is a three-way stop-controlled intersection with a single stop sign for vehicles traveling both directions on Windmill Ridge Road and also on Cambria. The speed limit for traffic traveling on both Windmill Ridge Road and Cambria is 25 mph. An aerial view and ground images of Intersection 22 are presented in Figure 38 and Figure 39, respectively.

Figure 38 Aerial view of Windmill Ridge & Cambria intersection.

All three warnings occurred at the same intersection while making the same straight-crossing maneuver: traveling west on Windmill Ridge Road through the stop-controlled intersection of Windmill Ridge Road and Cambria Street (intersection identification number 23; refer to Figure 11 for intersection location on the route and to Appendix E for a description of the intersections). The intersection is in the middle of a straight road with a stop sign that is partially occluded at longer distances. The violation warnings were provided to three different drivers: a younger male, a middle-aged male, and an older male. In all three cases, they did not show indications of intending to stop prior to the warning, yet stopped before entering the intersection box after the warning was issued. The drivers' peak decelerations ranged from 0.46 g to 0.6 g and the average decelerations ranged from 0.33 g to 0.41 g.

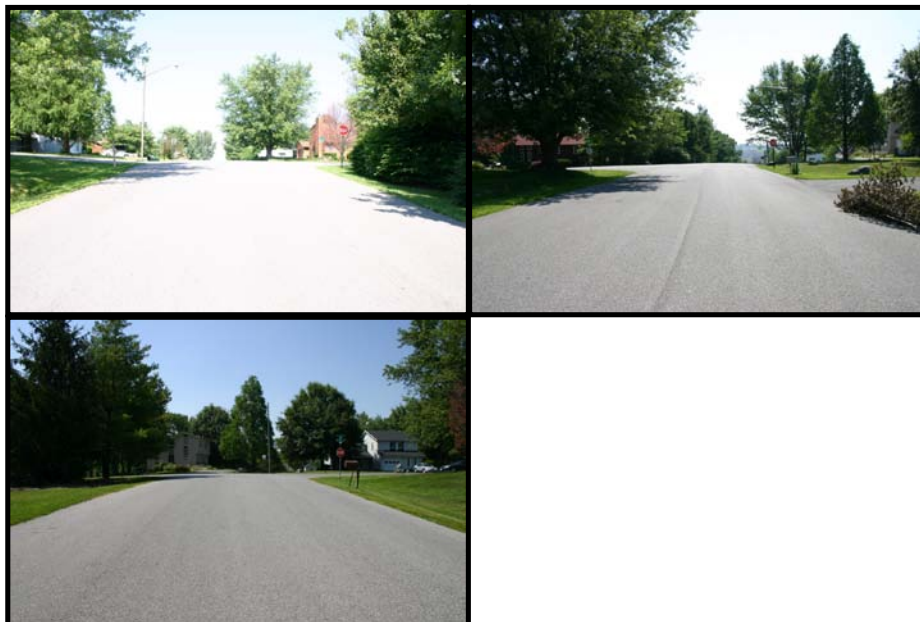
Figure 39 Ground images of Windmill Ridge & Cambria intersection.

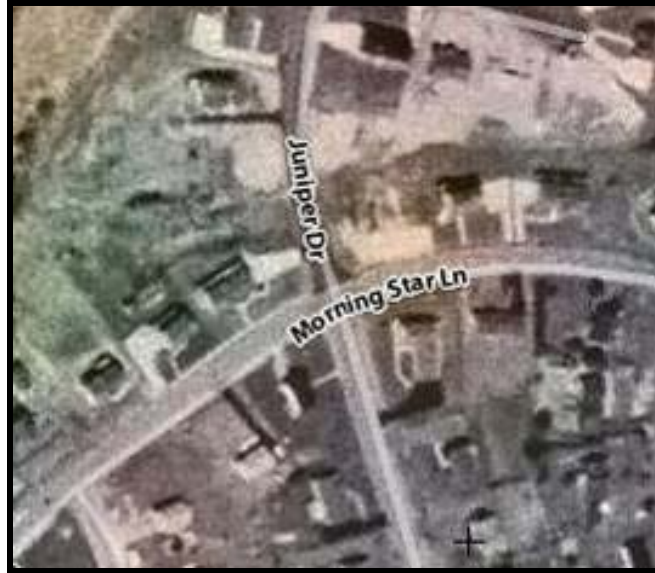
The intersection of Juniper Drive and Morning Star Lane (Intersection 23) is a four-way stop-controlled intersection with a single stop sign for vehicles traveling both directions on Juniper Drive. The speed limit for traffic traveling on both Juniper Drive and Morning Star Lane is 25 mph. An aerial view and ground images of Intersection 23 are presented in Figure 40 and Figure 41, respectively.

Figure 40 Aerial view of Juniper & Morning Star intersection.

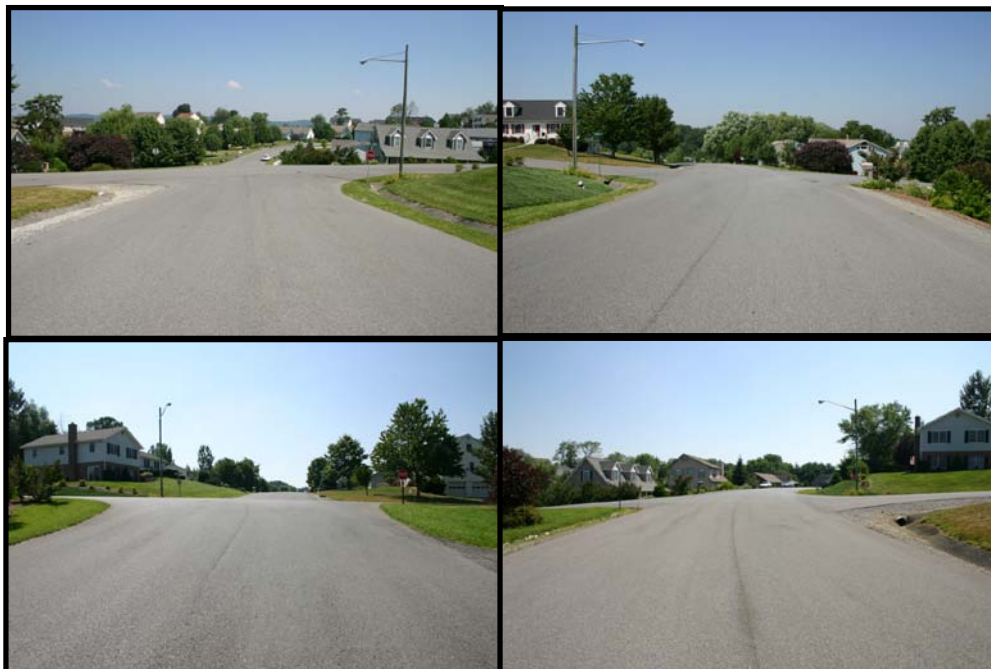
Figure 41 Ground images of Juniper & Morning Star intersection.

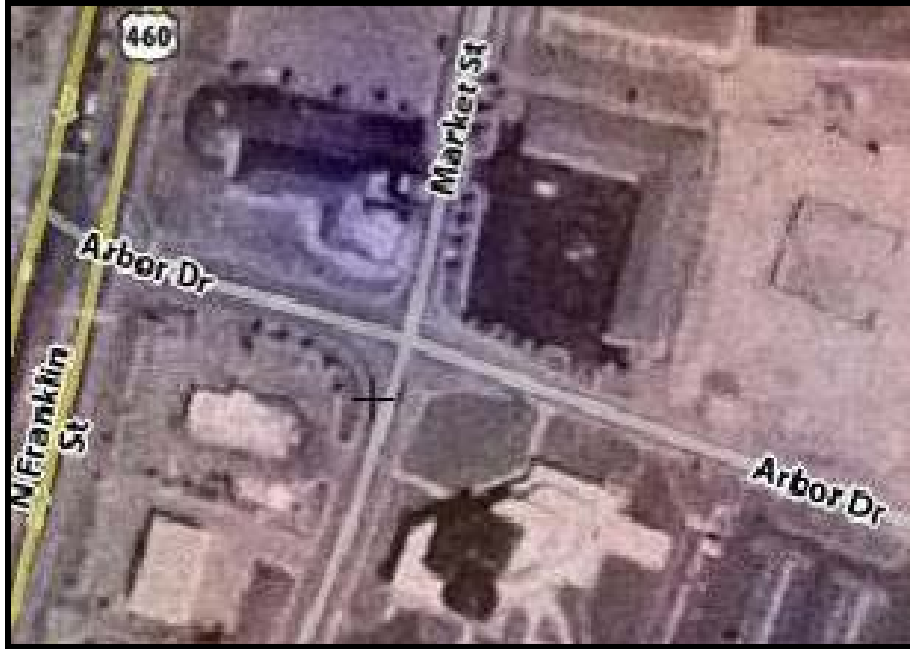
The intersection of Market Street and Arbor Drive (Intersection 25) is a four-way stop-controlled intersection with a single stop sign for vehicles traveling both directions on Market Street. The speed limit for traffic traveling on both Market Street and Arbor Drive is 25 mph. An aerial view and ground images of Intersection 25 are presented in Figure 42 and Figure 43, respectively.

Figure 42 Aerial view of Market & Arbor intersection.

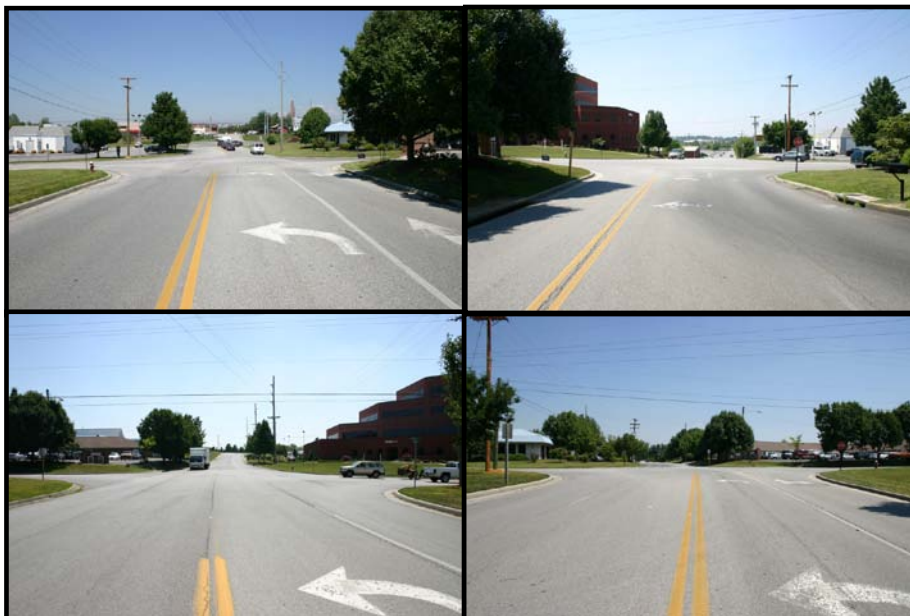
Figure 43 Ground images of Market & Arbor intersection.
