SEALANT, WATERPROOFING & RESTORATION INSTITUTE • FALL 2021 • 43.4

PERSISTENCY + PERSEVERANCE = PRESERVATION

BY JED DANIEL P.E.

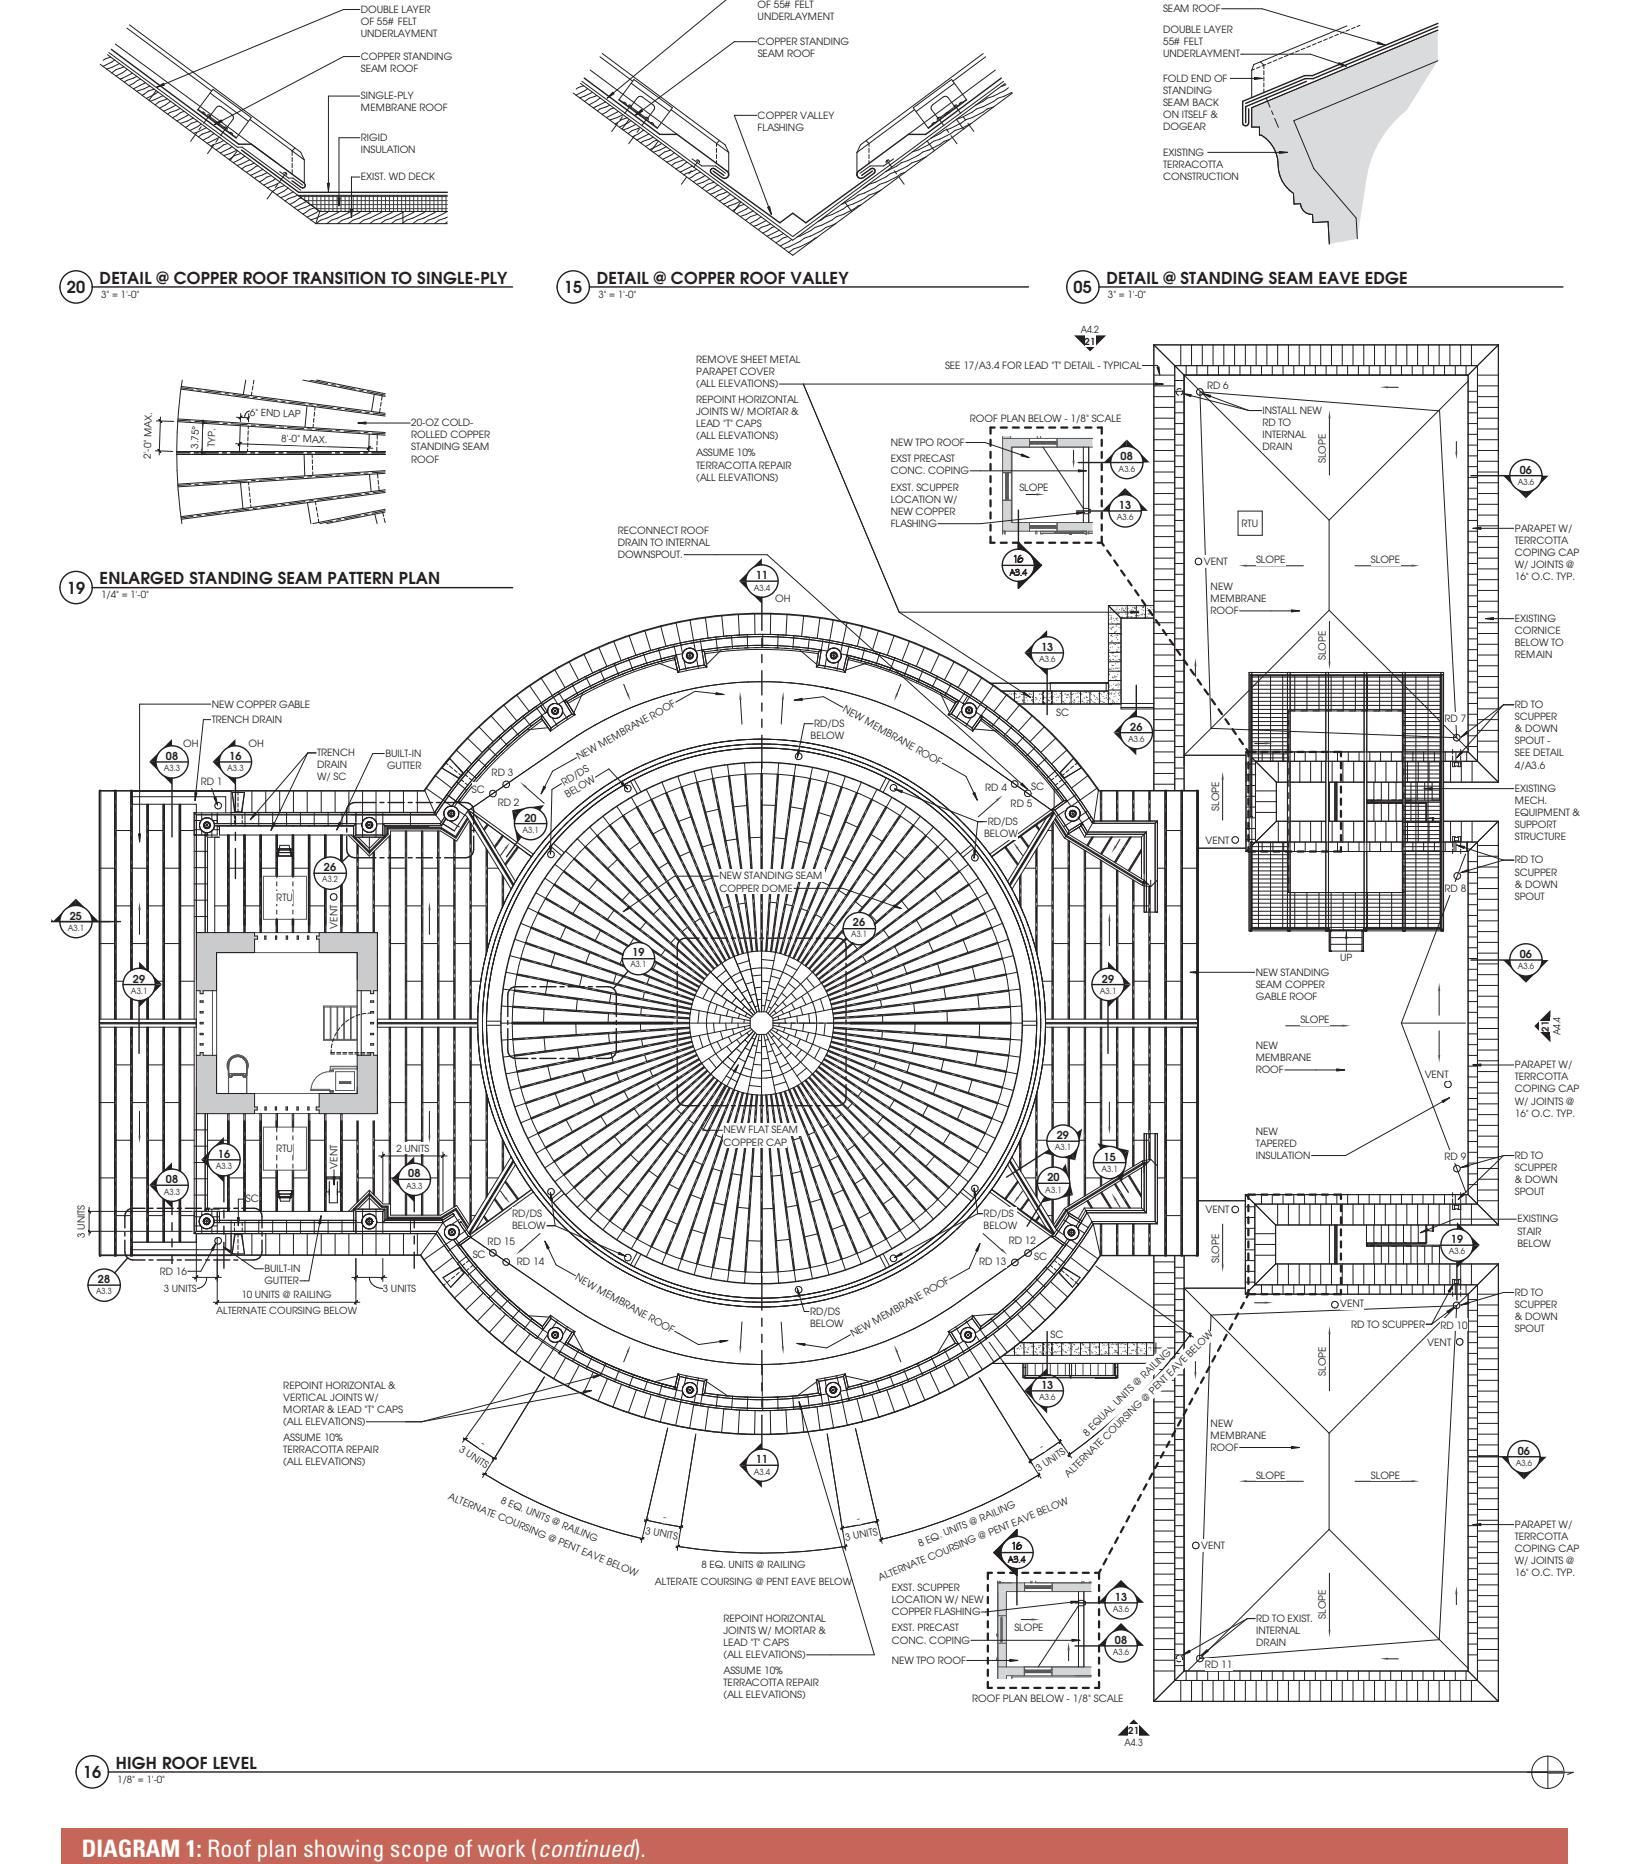
(28) MTL. ROOF - PIPE PENETRATION ROOF DETAIL

-DOUBLE LAYER OF 55# FELT UNDERLAYMENT

COPPER STANDING SEAM ROOF

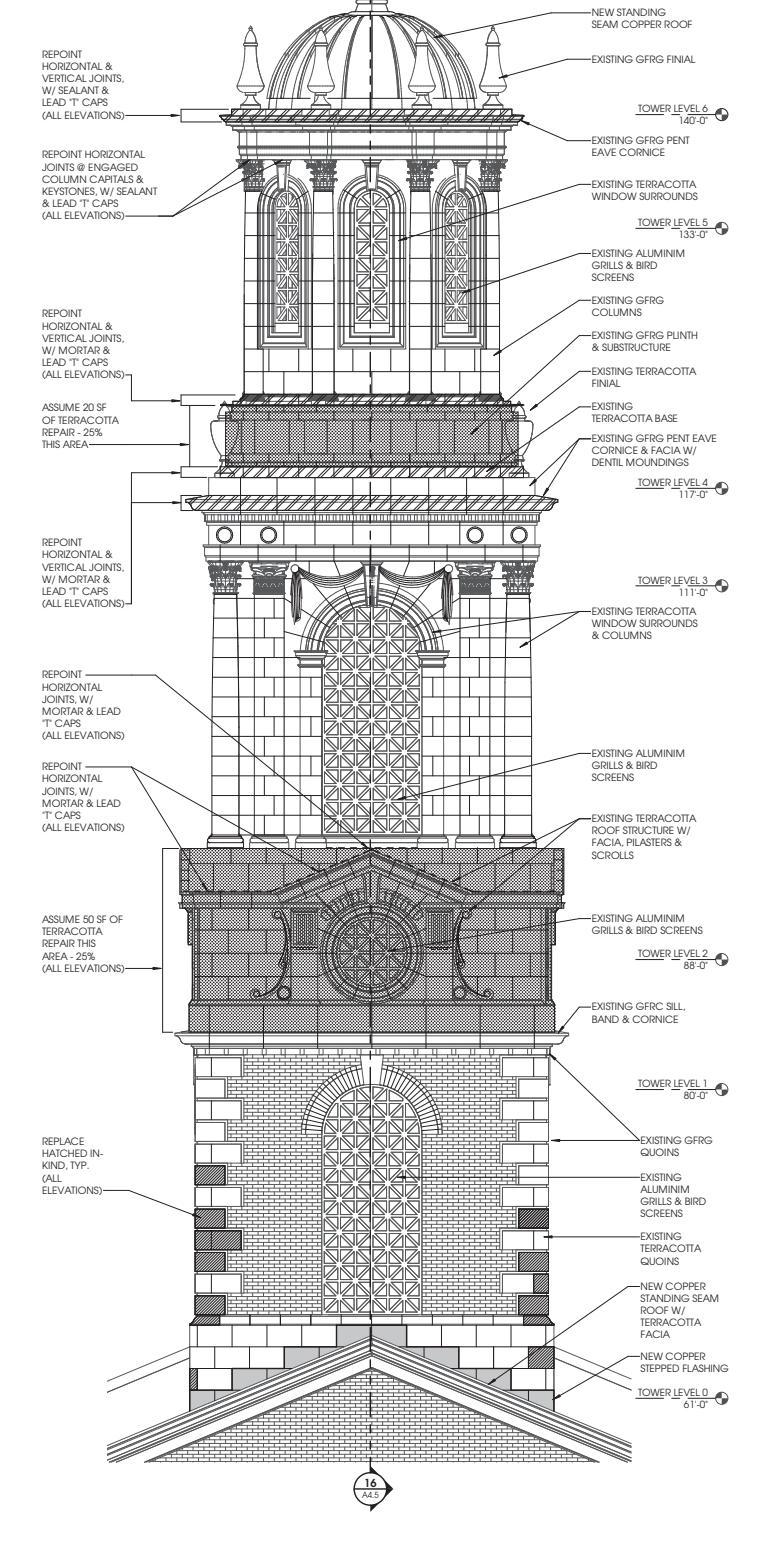
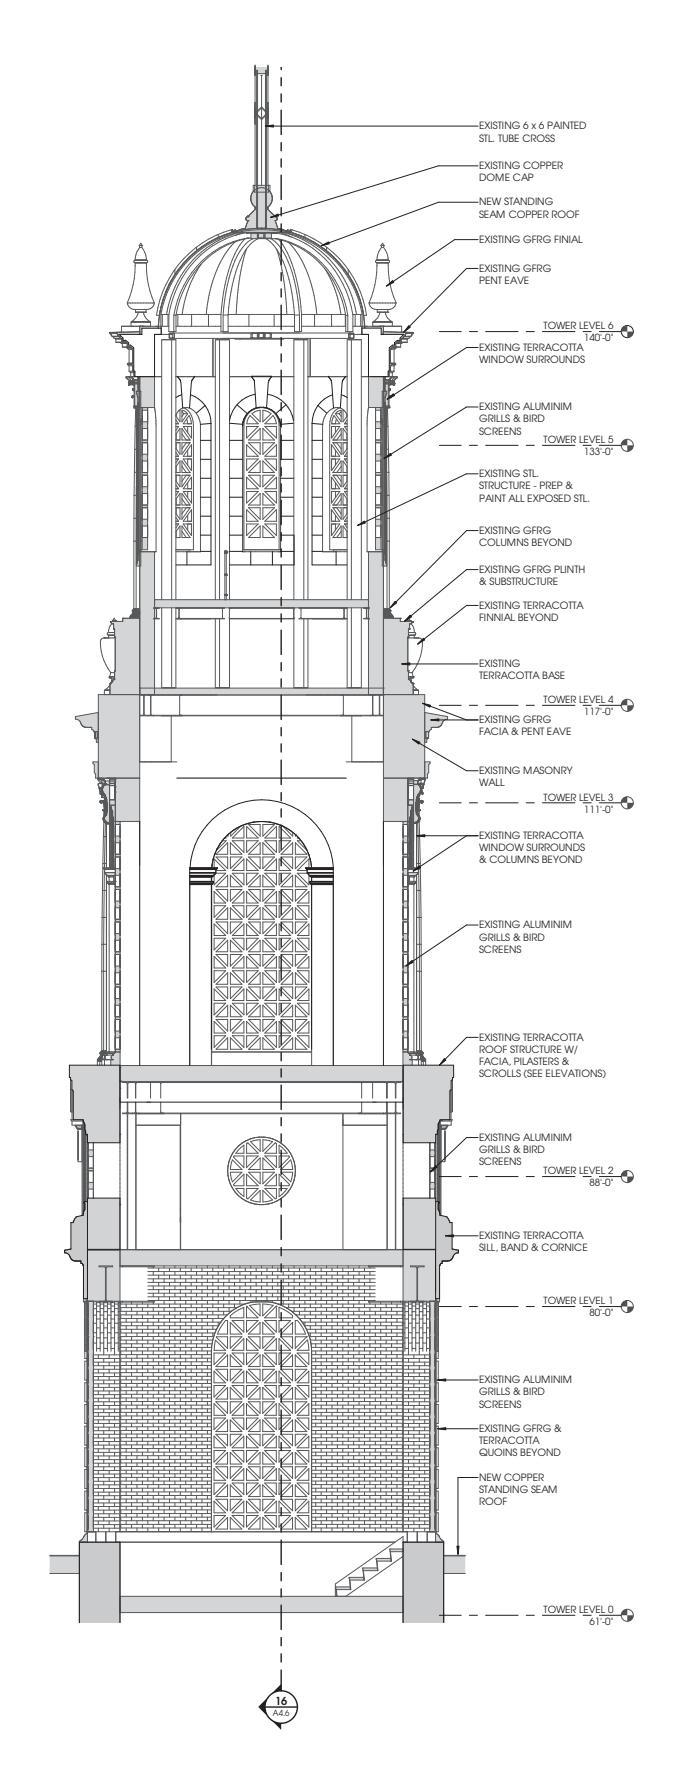
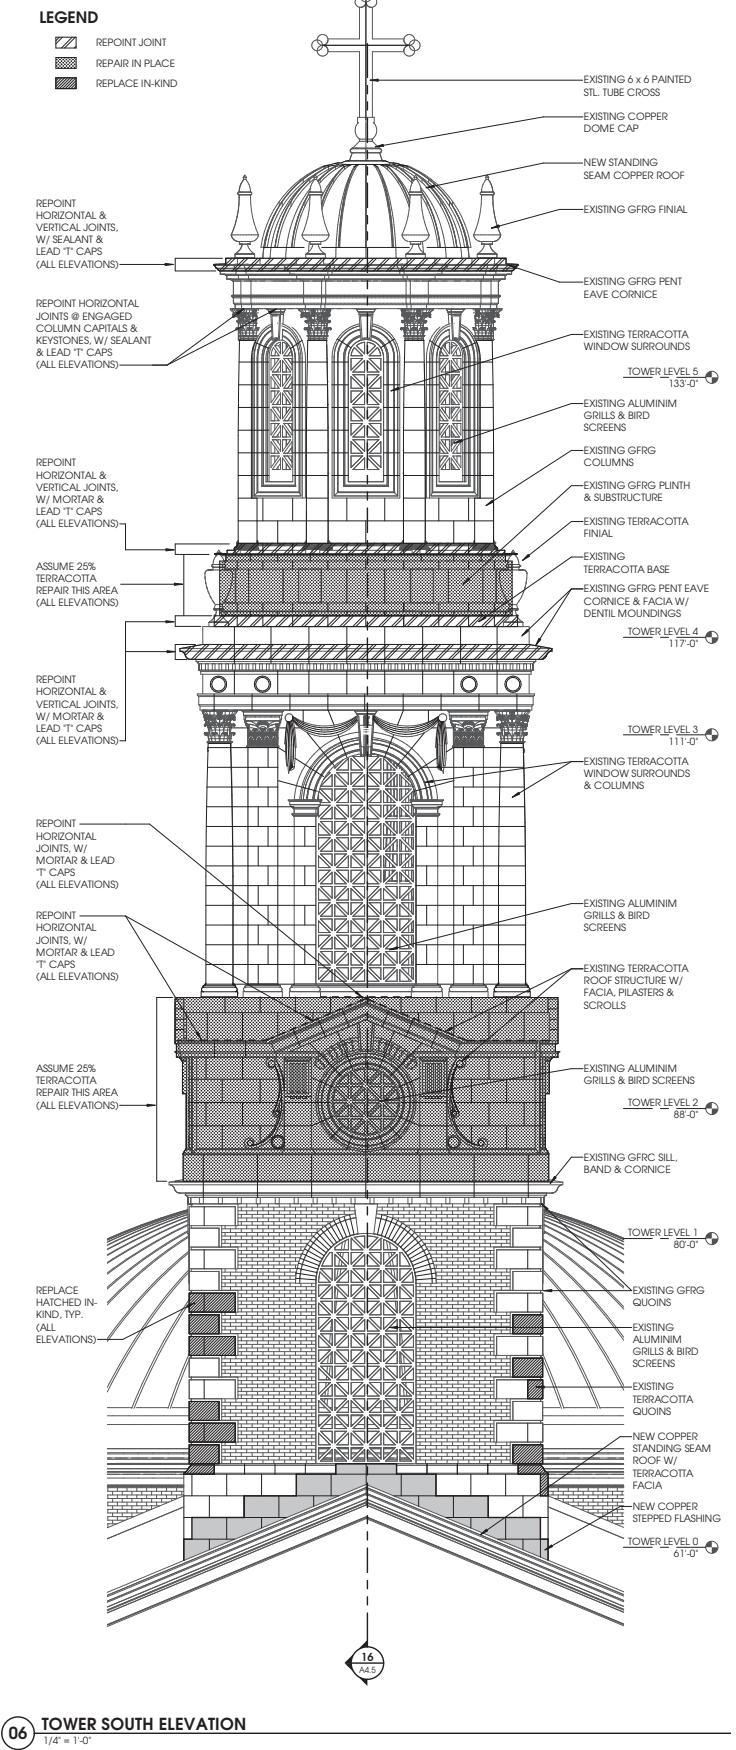
(26) TOWER NORTH ELEVATION

DIAGRAM 2: North elevation showing terra cotta unit pieces.

DIAGRAM 2: North elevation showing terra cotta unit pieces (continued)

As stated, TCU replication required approximately a sixto-seven-month lead time. The first step was to do a site survey (tap and map) to confirm if what is on the drawings is accurate (*Diagram* 2). Since a crane was not employed to confirm existing conditions, binoculars were used by the preservationist. For the most part, TCU replacement units were located at the lower corners of the Bell Tower, and the quantity was close to the allowance. Replication can be accomplished in multiple ways: extraction, photogrammetry, or simply field measurements. Accuracy is critical but decreases from option to option. In this case, WxP was instructed that absolutely no TCU would be removed from the site. As such, WxP relied completely on their field measurements and CAD drawings. Fortunately, most units needing to be replaced were corner ashlars not possessing ornate profiles. TCU phases included research and development (shop drawings, color match, lab test); molds and modeling; extraction; and replacement using appropriate anchorage. Final cost was determined based on number of molds (12 each) and replacement units (41 each). In the end, final TCU cost was close to budget.
