MOUNT CONSTRUCTION COMPLETES EMERGENCY PROJECT

Collapsed Interceptor At Major Artery Replaced In Two Months

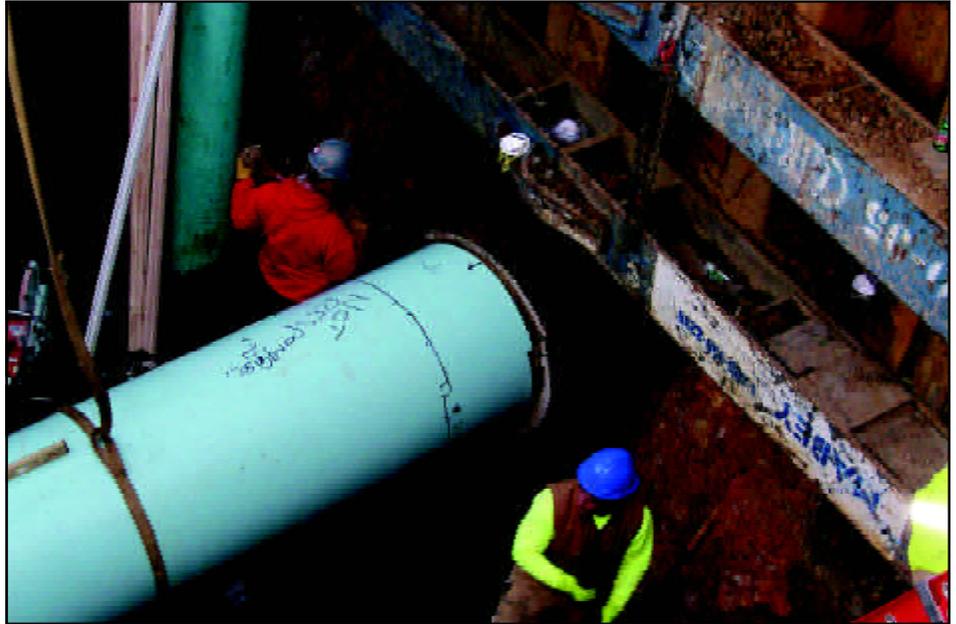
Mount personnel prepare for the installation of the SDR 35 PVC pipe.

Mount then installed 700 linear feet of 36 inch diameter SDR 35 PVC pipe and four new manholes. The hole was backfilled using compacted DGA which was place in six foot

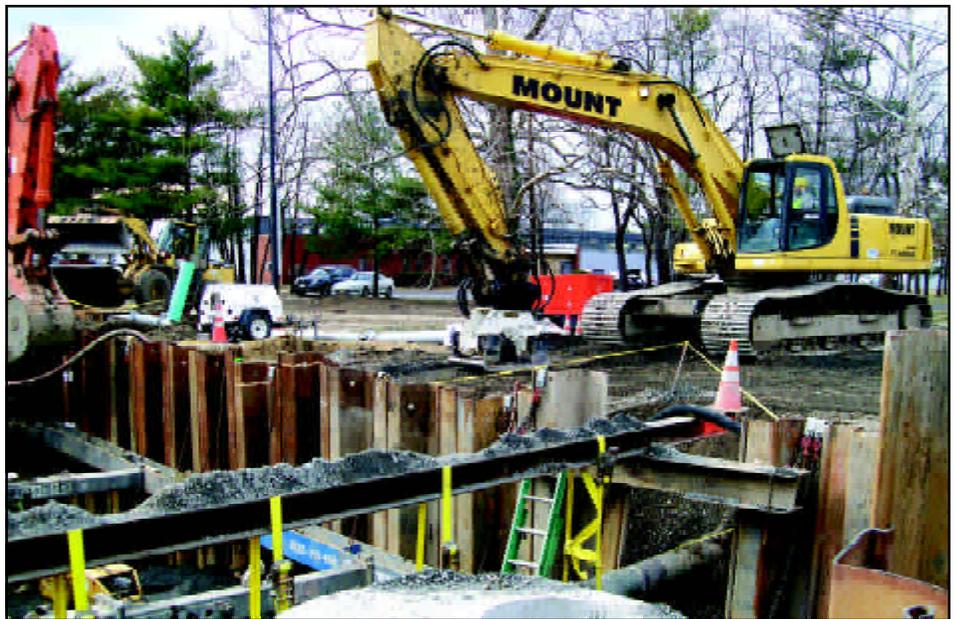
A portion of the deep pit that was constructed to install the pipe.

The next step involved the removal of the approach decks on the westside of the bridge. Mount forces sawcut six feet by eight feet slabs which were removed by a crane and each slab was sent to the contractor's yard for recycling. The firm then installed sheeting, shoring and whalers. Mount drove sheeting with the use of a 100 ton crane. Excavation then followed, with approximately 2700 yards of material removed. The work pit was excavated to a depth of 21 feet which is significant due to the fact that high tide is eleven feet above the depth of the excavation. Mount's crew then removed 700 feet of collapsed pipe, and the bottom of the excavated area was stabilized using geotextile fabric and aggregate.
