# Case History

<b>Type of Project / Name:</b>	<b>Concrete Roof Restoration</b>
<b>Location:</b>	<b>Teaneck, NJ</b>
<b>Specification:</b>	<b>SI-38-GF20 with LM-60</b>
<b>Architect:</b>	<b>LAN Associates</b>
<b>Contractor:</b>	<b>Hollister Construction Services, General Contractor Strober Wright Roofing, Roof Contractor Hygrade Insulators, Insulation and Coating Contractor</b>
<b>Customer:</b>	<b>Fairleigh Dickinson University</b>
<b>Problem to be Solved:</b>	<b>Concrete roof deck needed an extra-strength waterproofing solution.</b>
<b>Completion Date:</b>	<b>June 2016</b>

GacoFlex S20 Roof Coating System /  
Concrete Roof Restoration, Teaneck, NJ

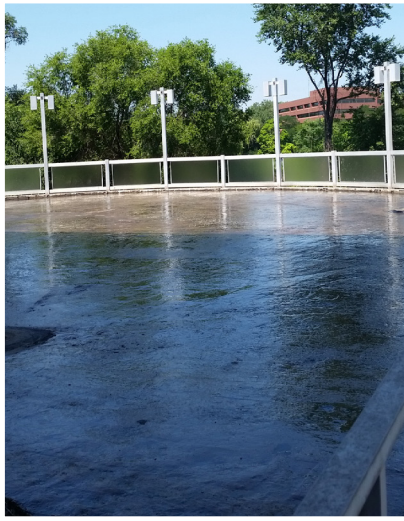
**GacoFlex E5990 100% Solids Two Component Primer/Sealer.**

was scarified in order to remove old tar and create a surface profile. After moisture testing with an RH Probe (.85) the team determined that it would be necessary to use GacoFlex E5990 100% Solids Two Component Primer/Sealer as a moisture barrier. After application and ample dry time, GacoFlex E5320 2-Part Epoxy Primer/Filler was applied. This easy-to-apply primer bonds to properly prepared roofing surfaces and improves adhesion of GacoFlex silicone coatings and other top coats, especially on weathered surfaces that are difficult to get completely clean.

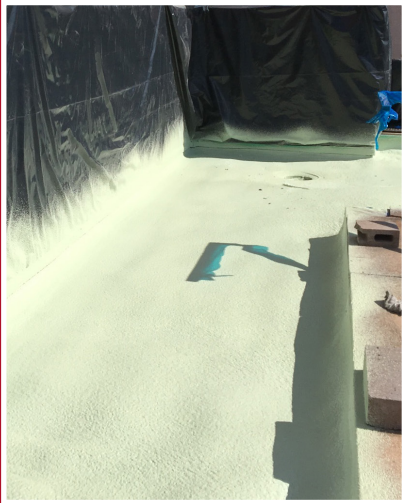
**GacoRoofFoam 2733 Closed Cell Spray Polyurethane Roofing Foam.**

Next GacoRoofFoam 2733 Closed Cell Spray Polyurethane Roofing Foam was sprayed at a 2" thickness (3" thickness on vertical surfaces) and then a single coat of GacoFlex S20 Solvent-Free 100% Silicone Coating was applied. A second coat of S20 was applied to flashings and edge terminations.

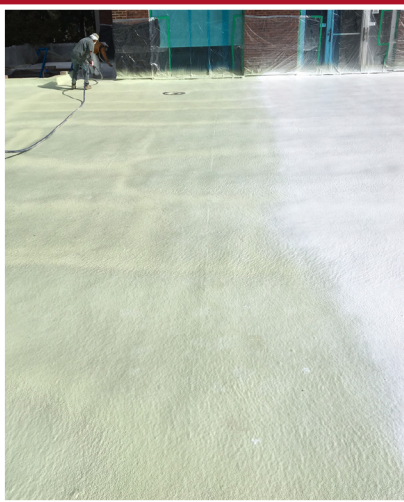
**GacoRoofFoam 2733 Closed Cell Spray Polyurethane Roofing Foam being coated with GacoFlex S20 Silicone Roof Coating.**
